PBY Catalina

Walk Around Number 5
squadron/signal publications

By William Scarborough
Color by Don Greer
Illustrated by Joe Sewell

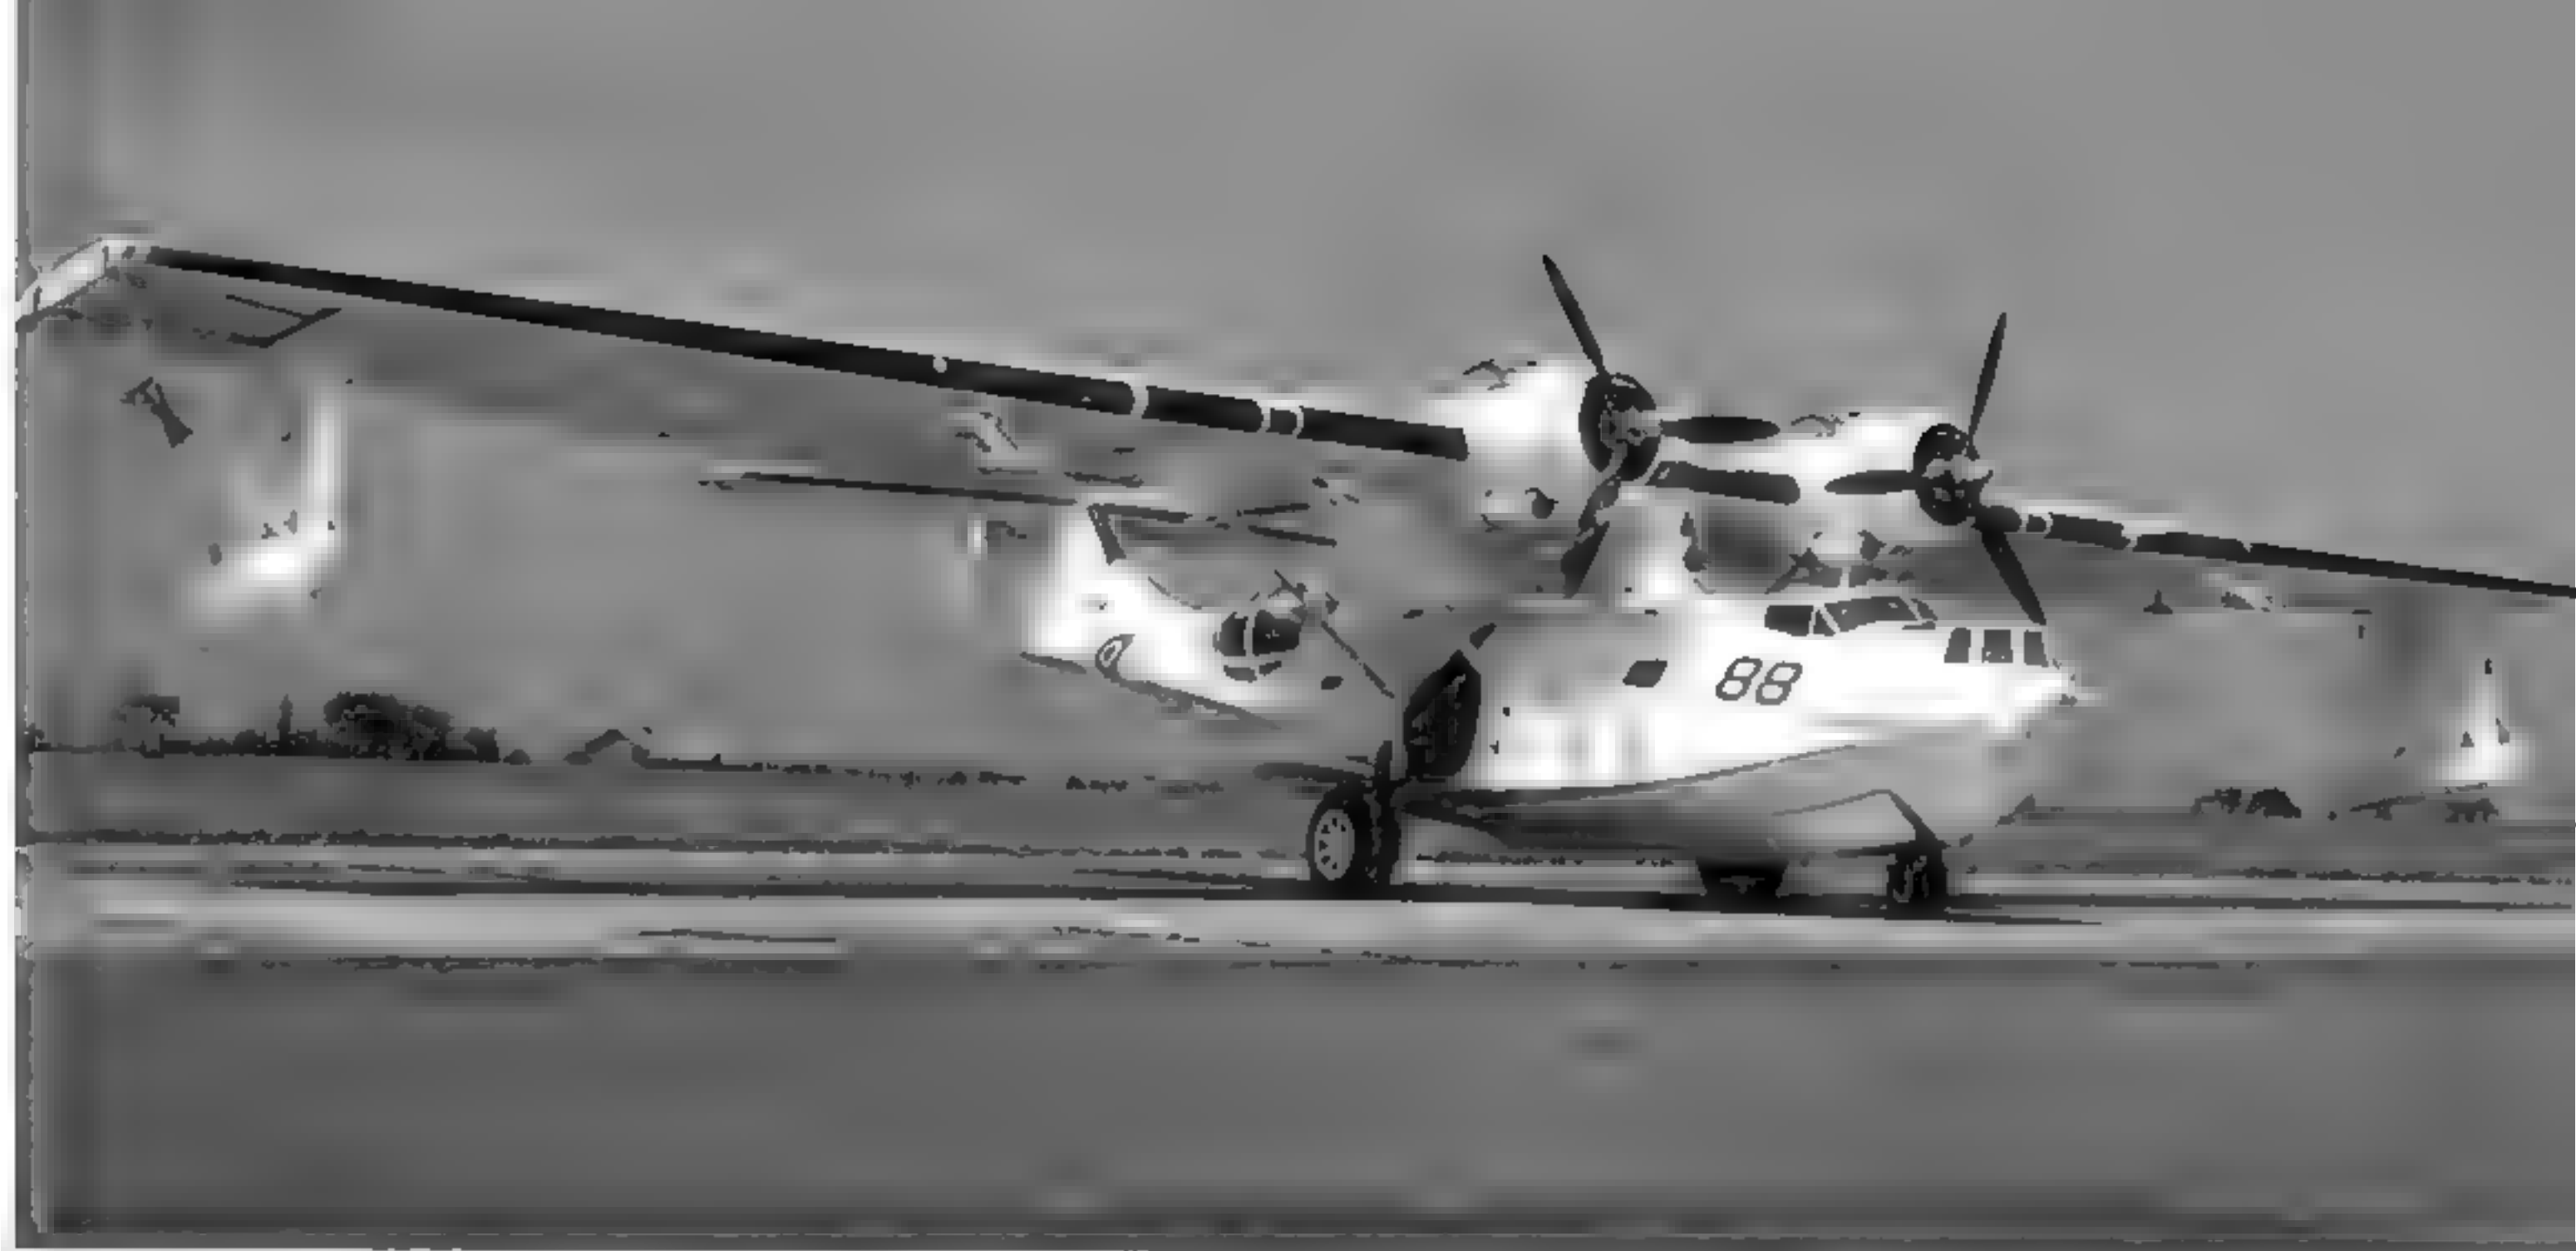
Normally, when operating from land bases, the wing tip floats were retracted for takeoff and flight, but were lowered to serve as post flight tie-downs. The strut coming back to the wing from the X float support struts was the float retraction linkage strut. When retracting the float supports folded inward at the cross of the "X". This is a Canadian-built Vickers Canso A.

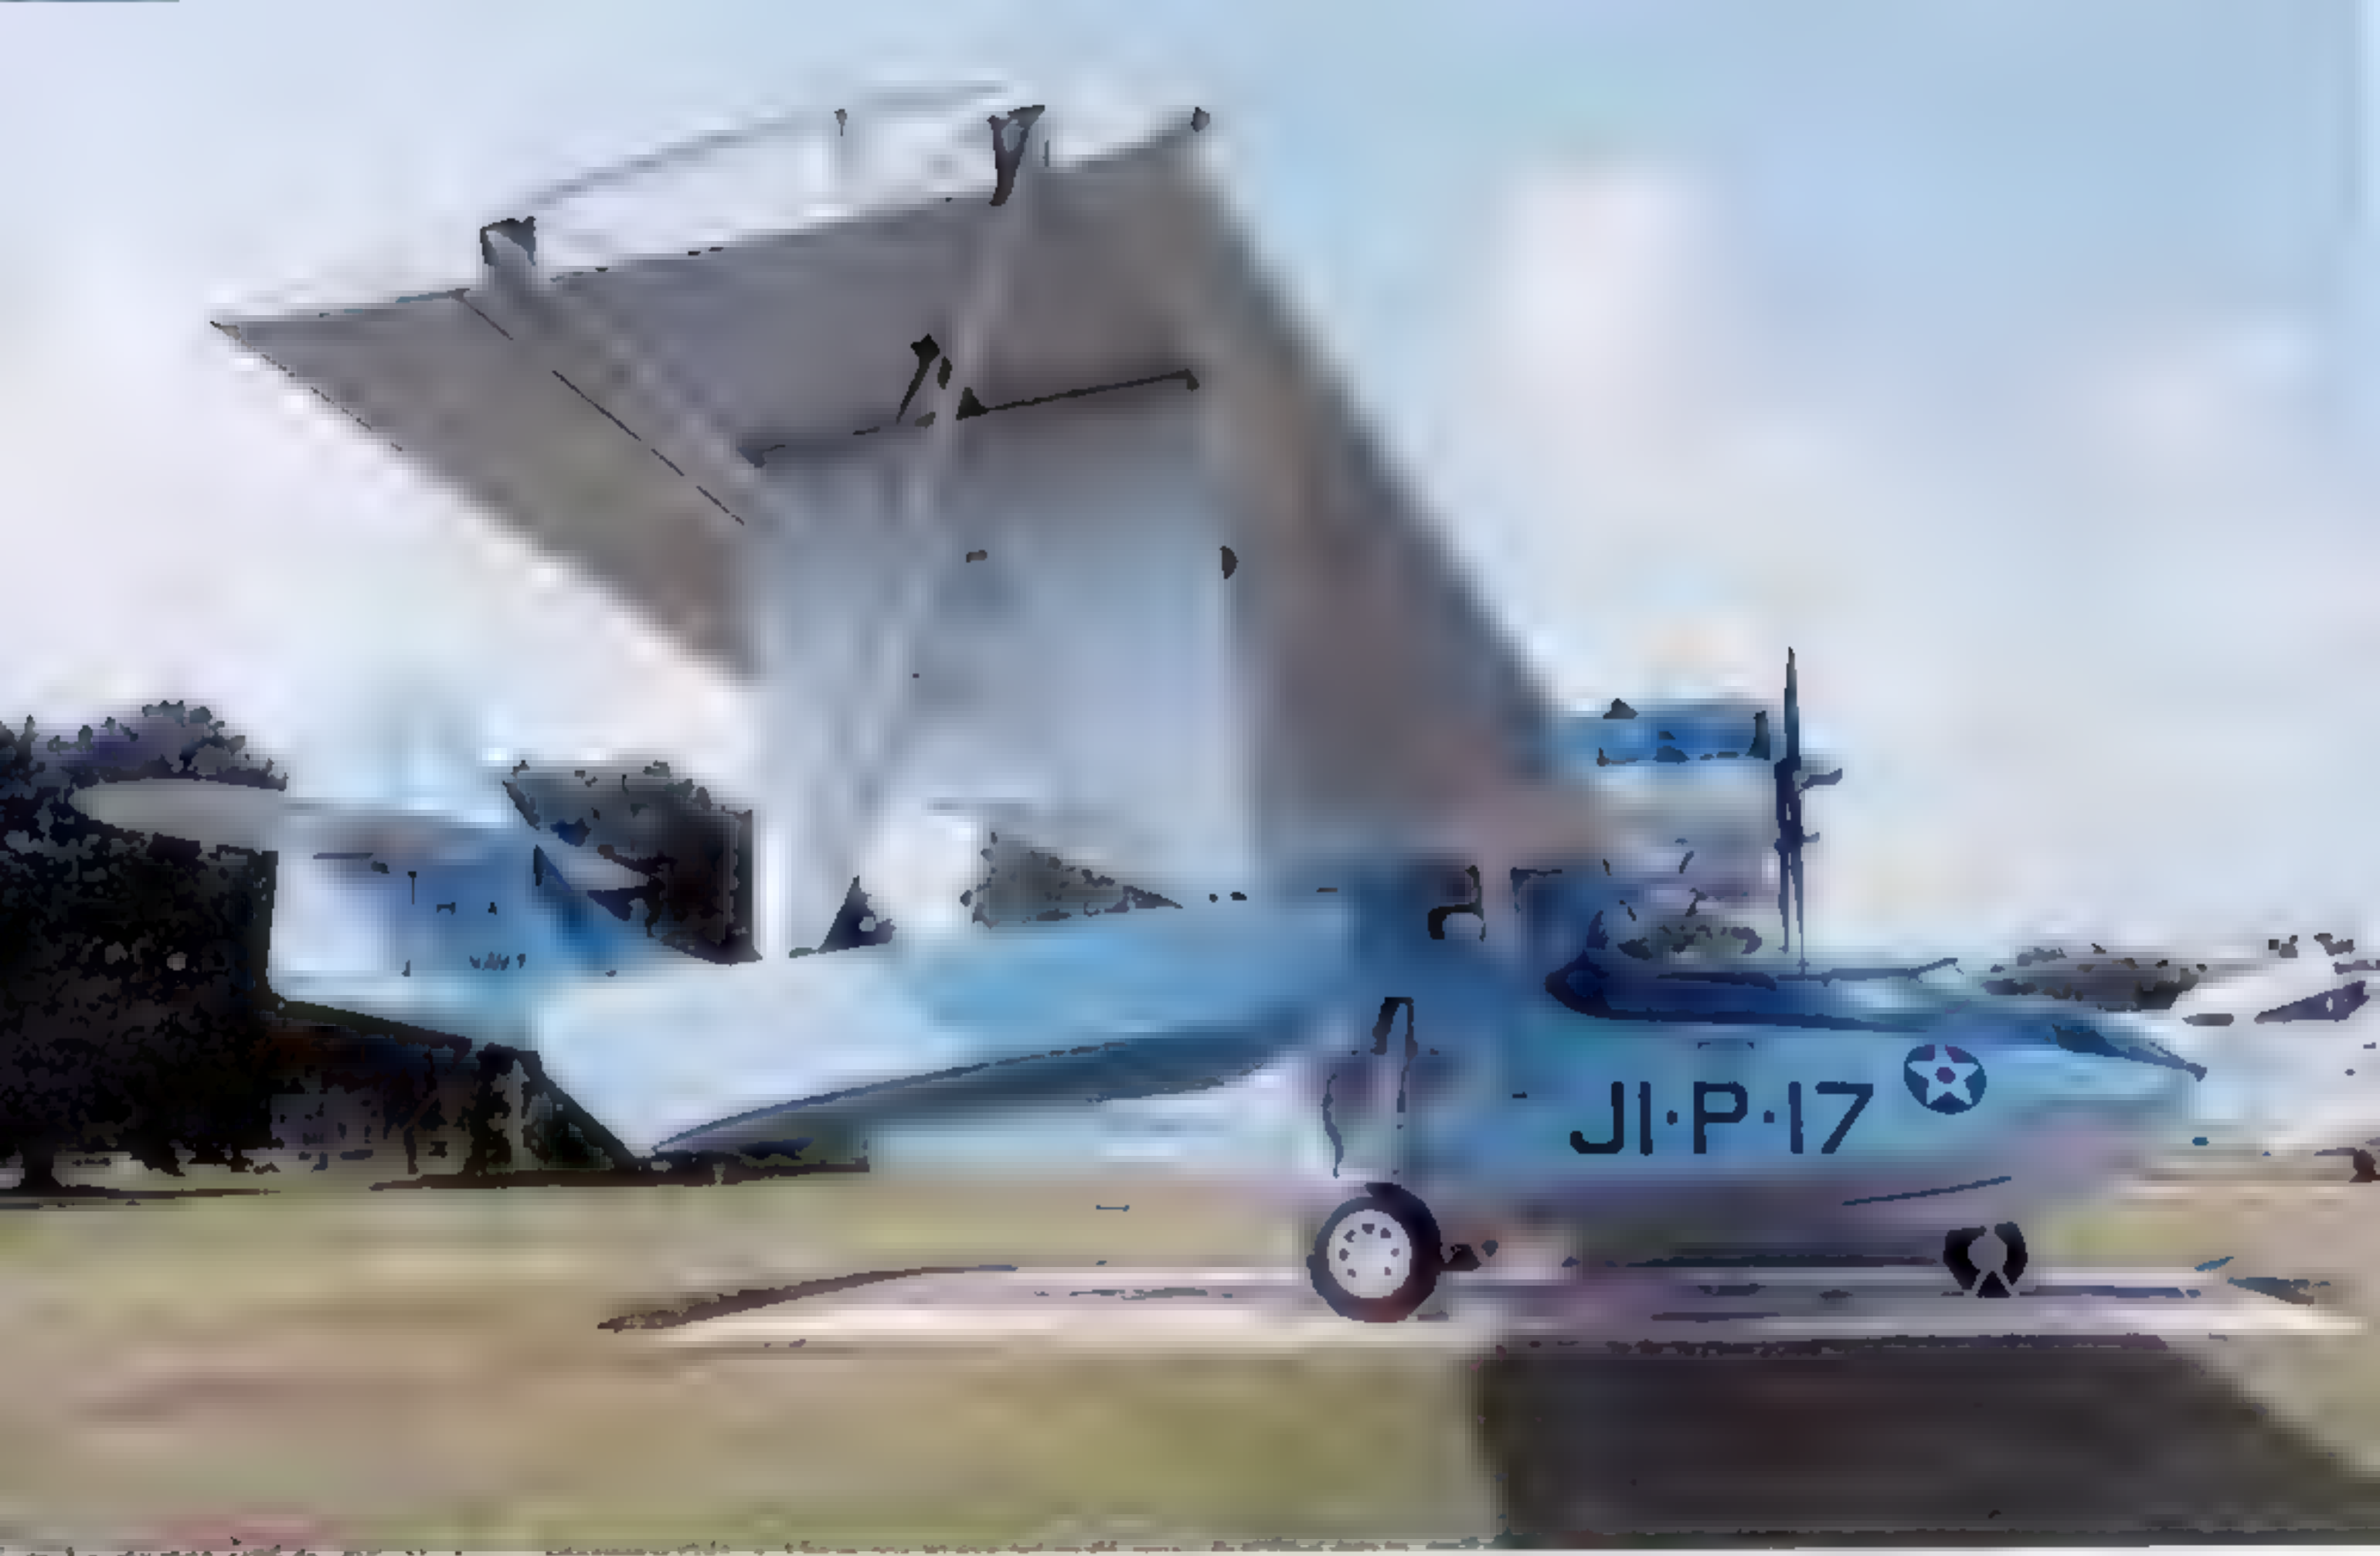
This restored PB4Y-2 is on display at Naval Air Station Jacksonville Florida. The wing tip floats are in the full down position. The strut coming back off the strut support struts is the retraction linkage which retracts into the well within the float well. The float support struts fold inward tying in the notches in the wing tip. The Jacksonville PB4Y was modified with the bow turret being removed and faired over. The aircraft was painted with the wrong colors and markings. In addition, the tail codes are presented wrong and the fuselage codes are presented wrong for this type of paint scheme. (Richard Dann)

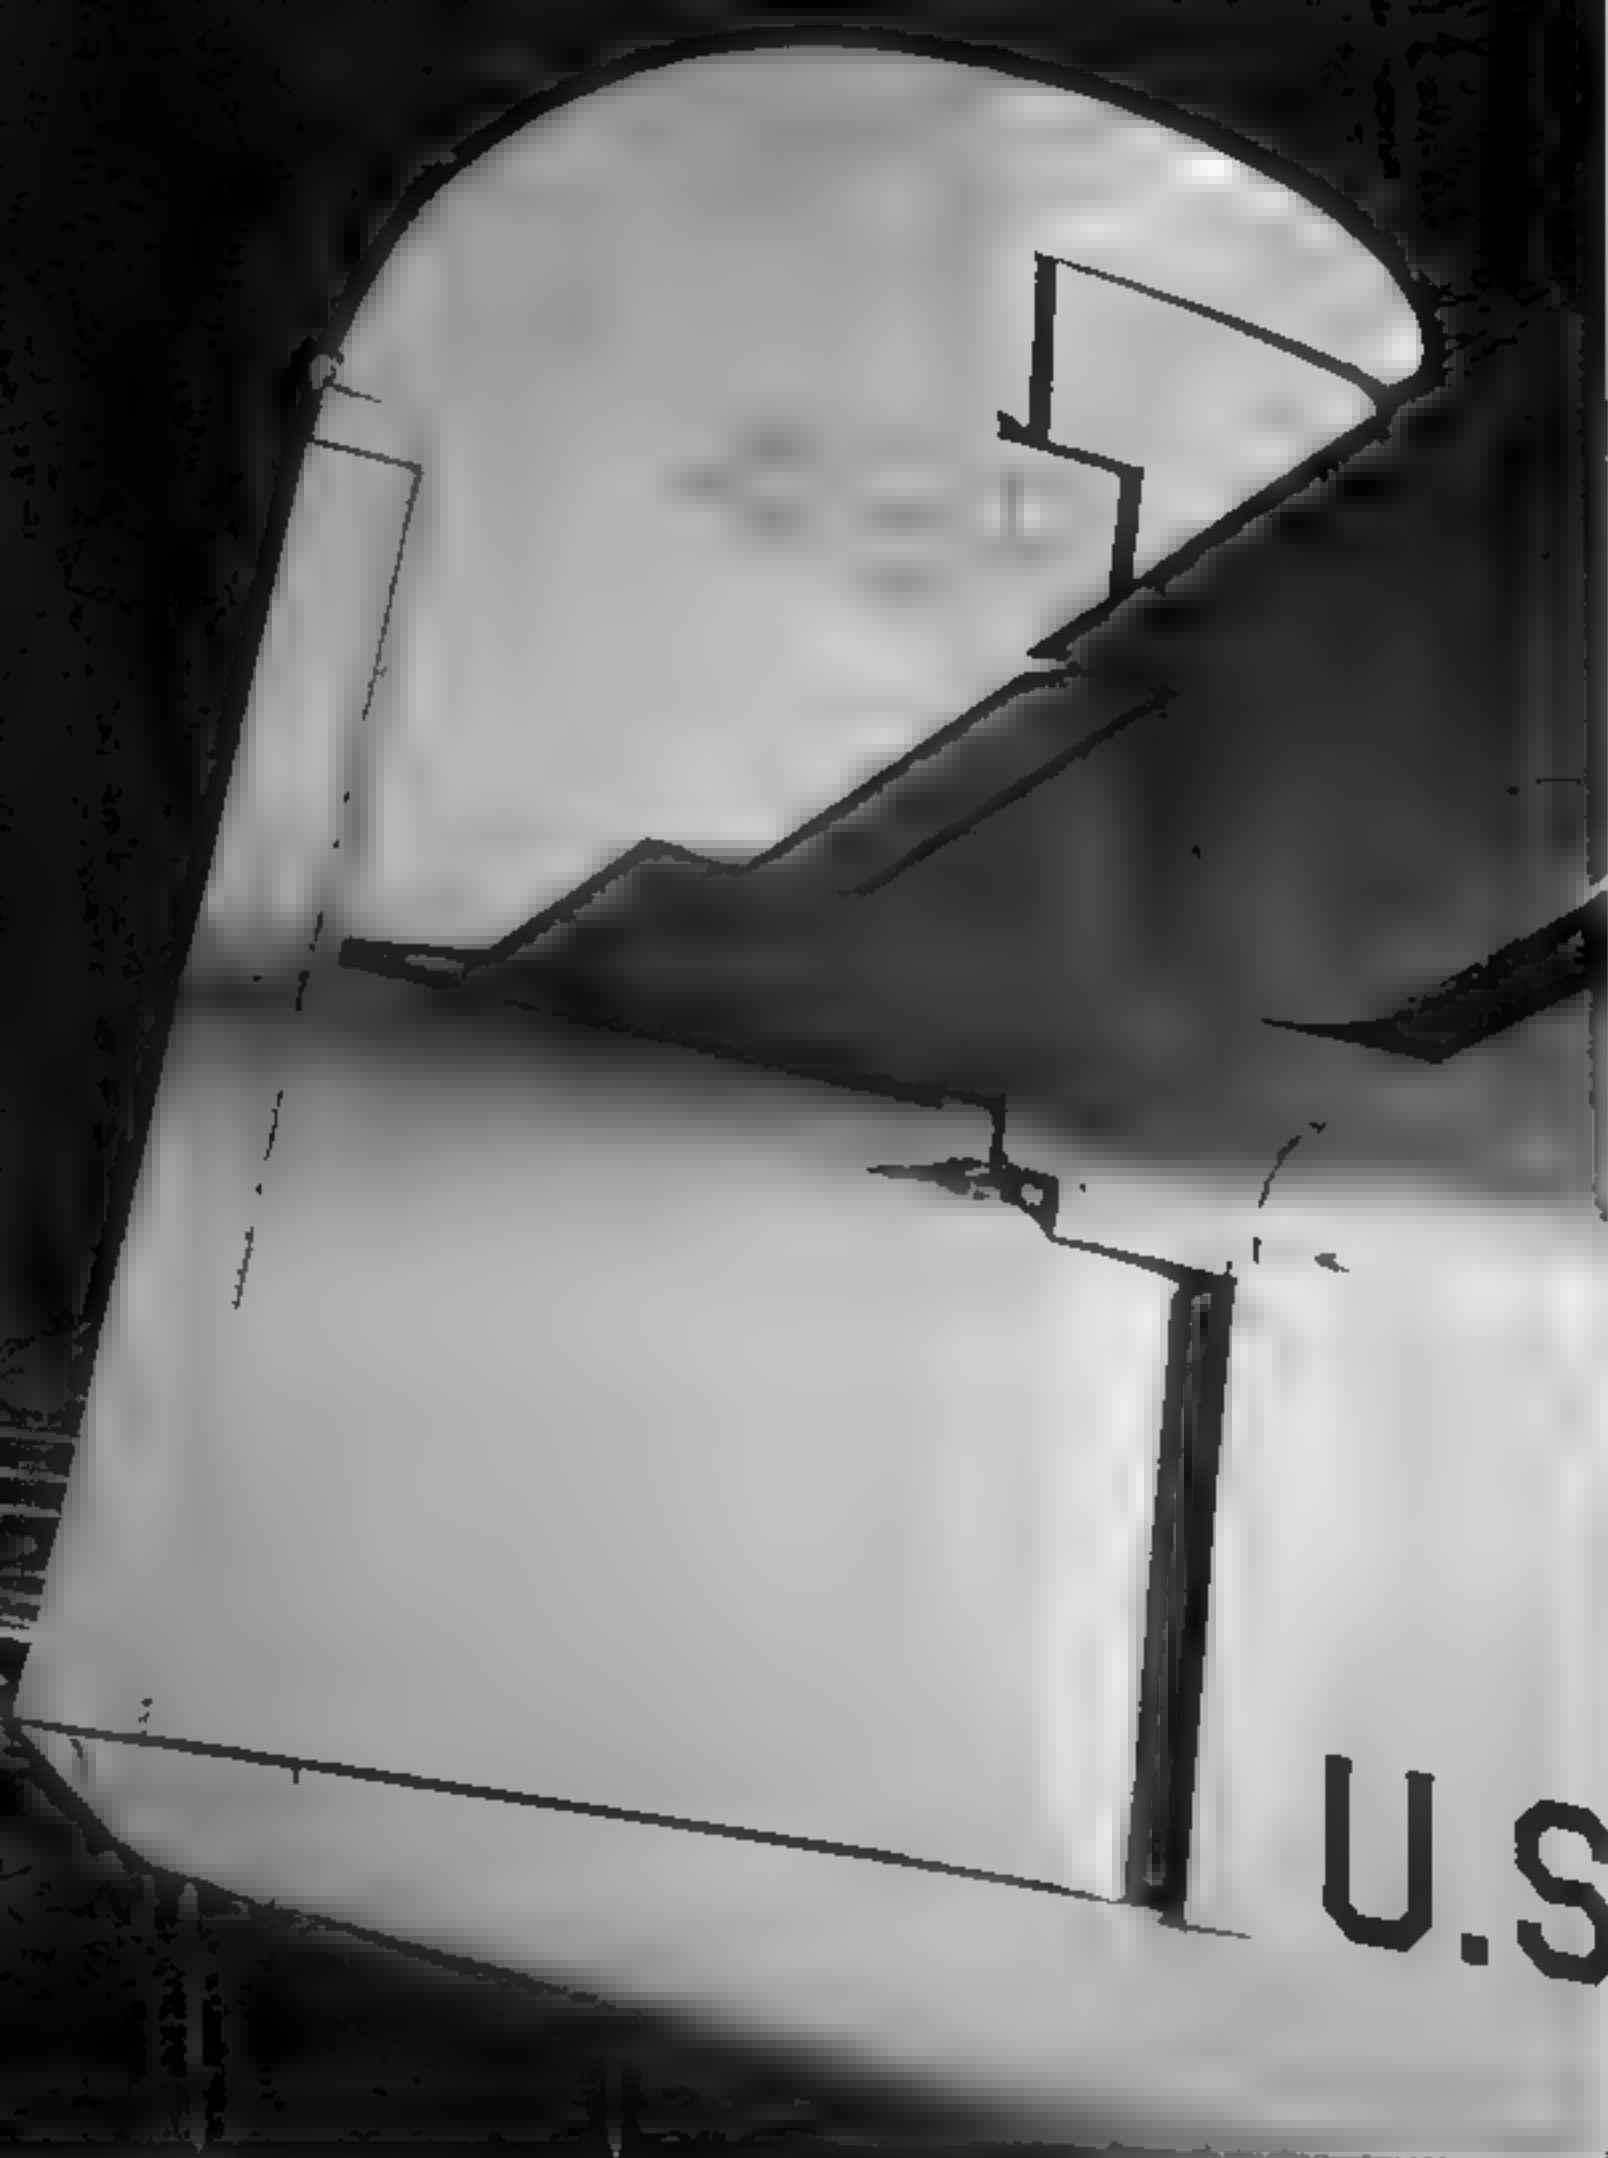
Side by side it is easy to see the differences in the fin and rudder area of the PBX-5A (left) and PBX-6A (Right). The PBX-6A had a three and a half foot taller fin and rudder. This tail modification was derived from engineering and wind tunnel studies which led to superior control responses on the PBN-1, these modifications were then incorporated into the PBX-6. The rudder balance forward of the hinge line on the PBX-5 was a post war civil modification intended to improve handling and reduce control forces. (Mark Aldrich)

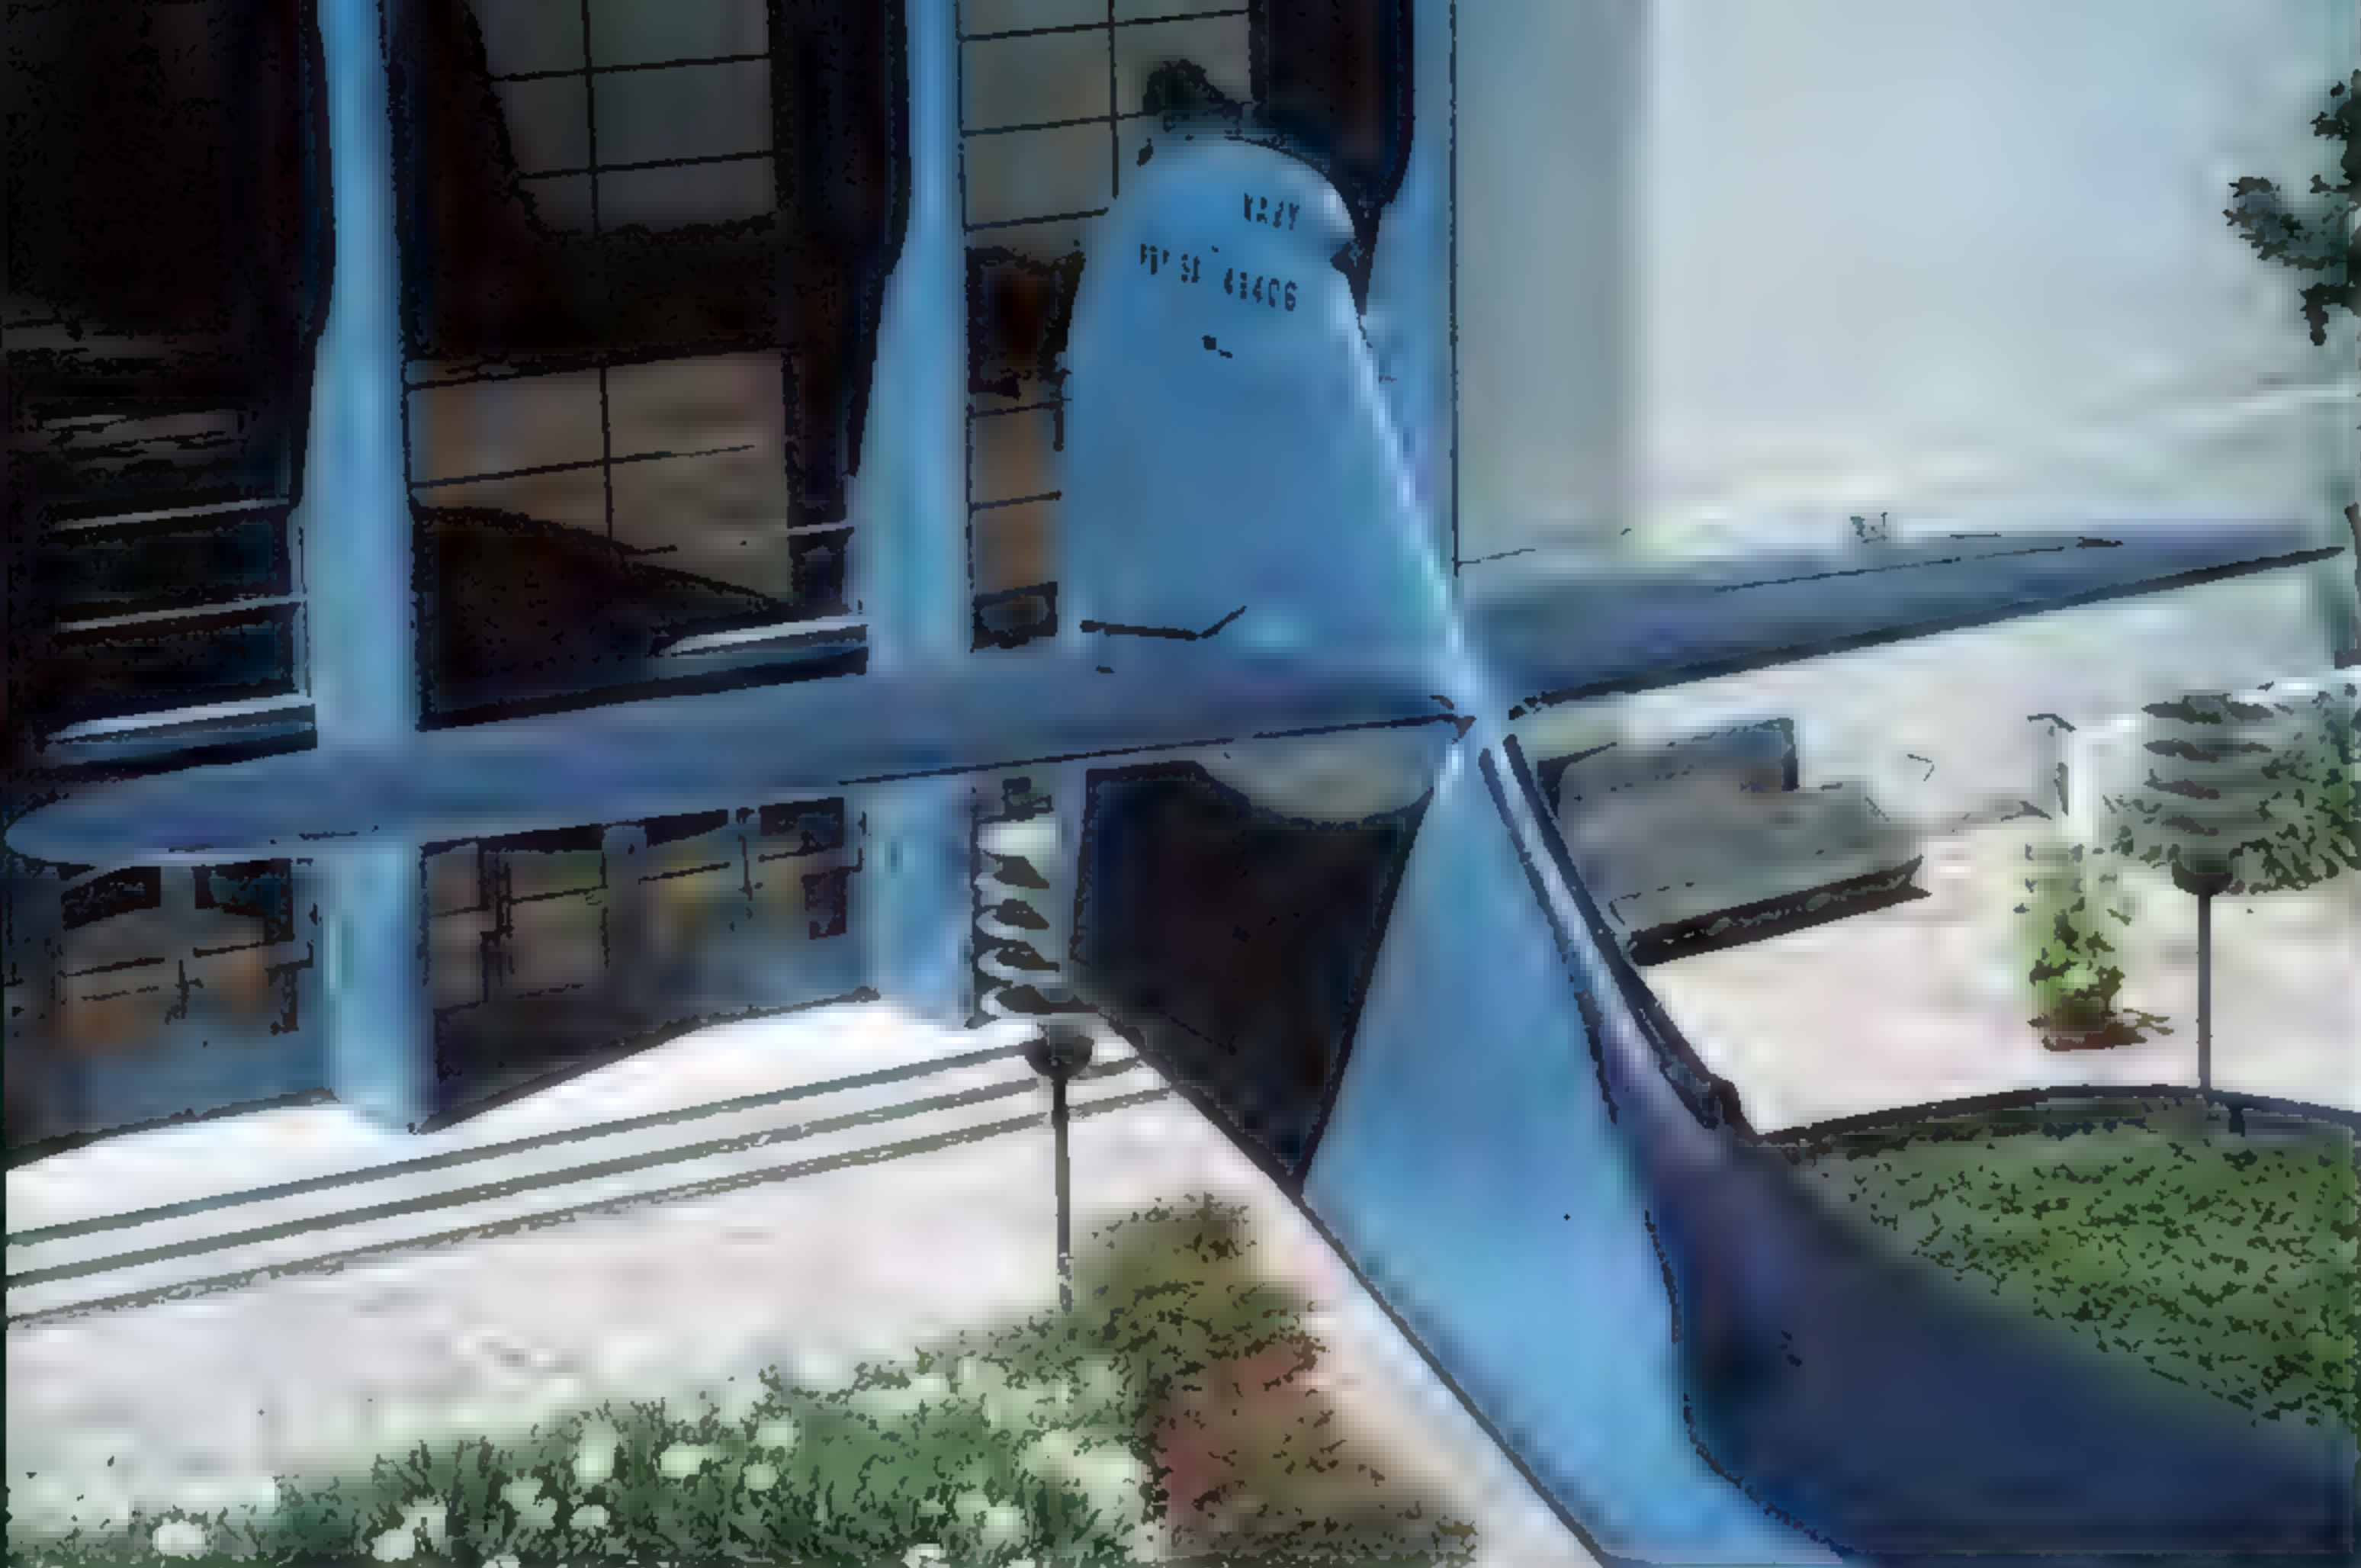
The vertical and horizontal stabilizers and control surfaces of the PBY-5A at the San Diego Aerospace Museum. The elevators are inset in the horizontal stabilizer and both are equipped with trim tabs. The round fairing just above the rudder trim tab is the tail navigation light. The small white object just below the tip of the fin on the forward edge is an antenna wire insulator. At least three antenna wires are attached to this insulator. The protrusion at the base of the fin is the air intake for the thermal deicing system. The rudder balance forward of the rudder hinge line reduced control forces and was not found on service PBY-5/5As. It was probably a modification installed by the previous civil owner. (Mark Aldrich)

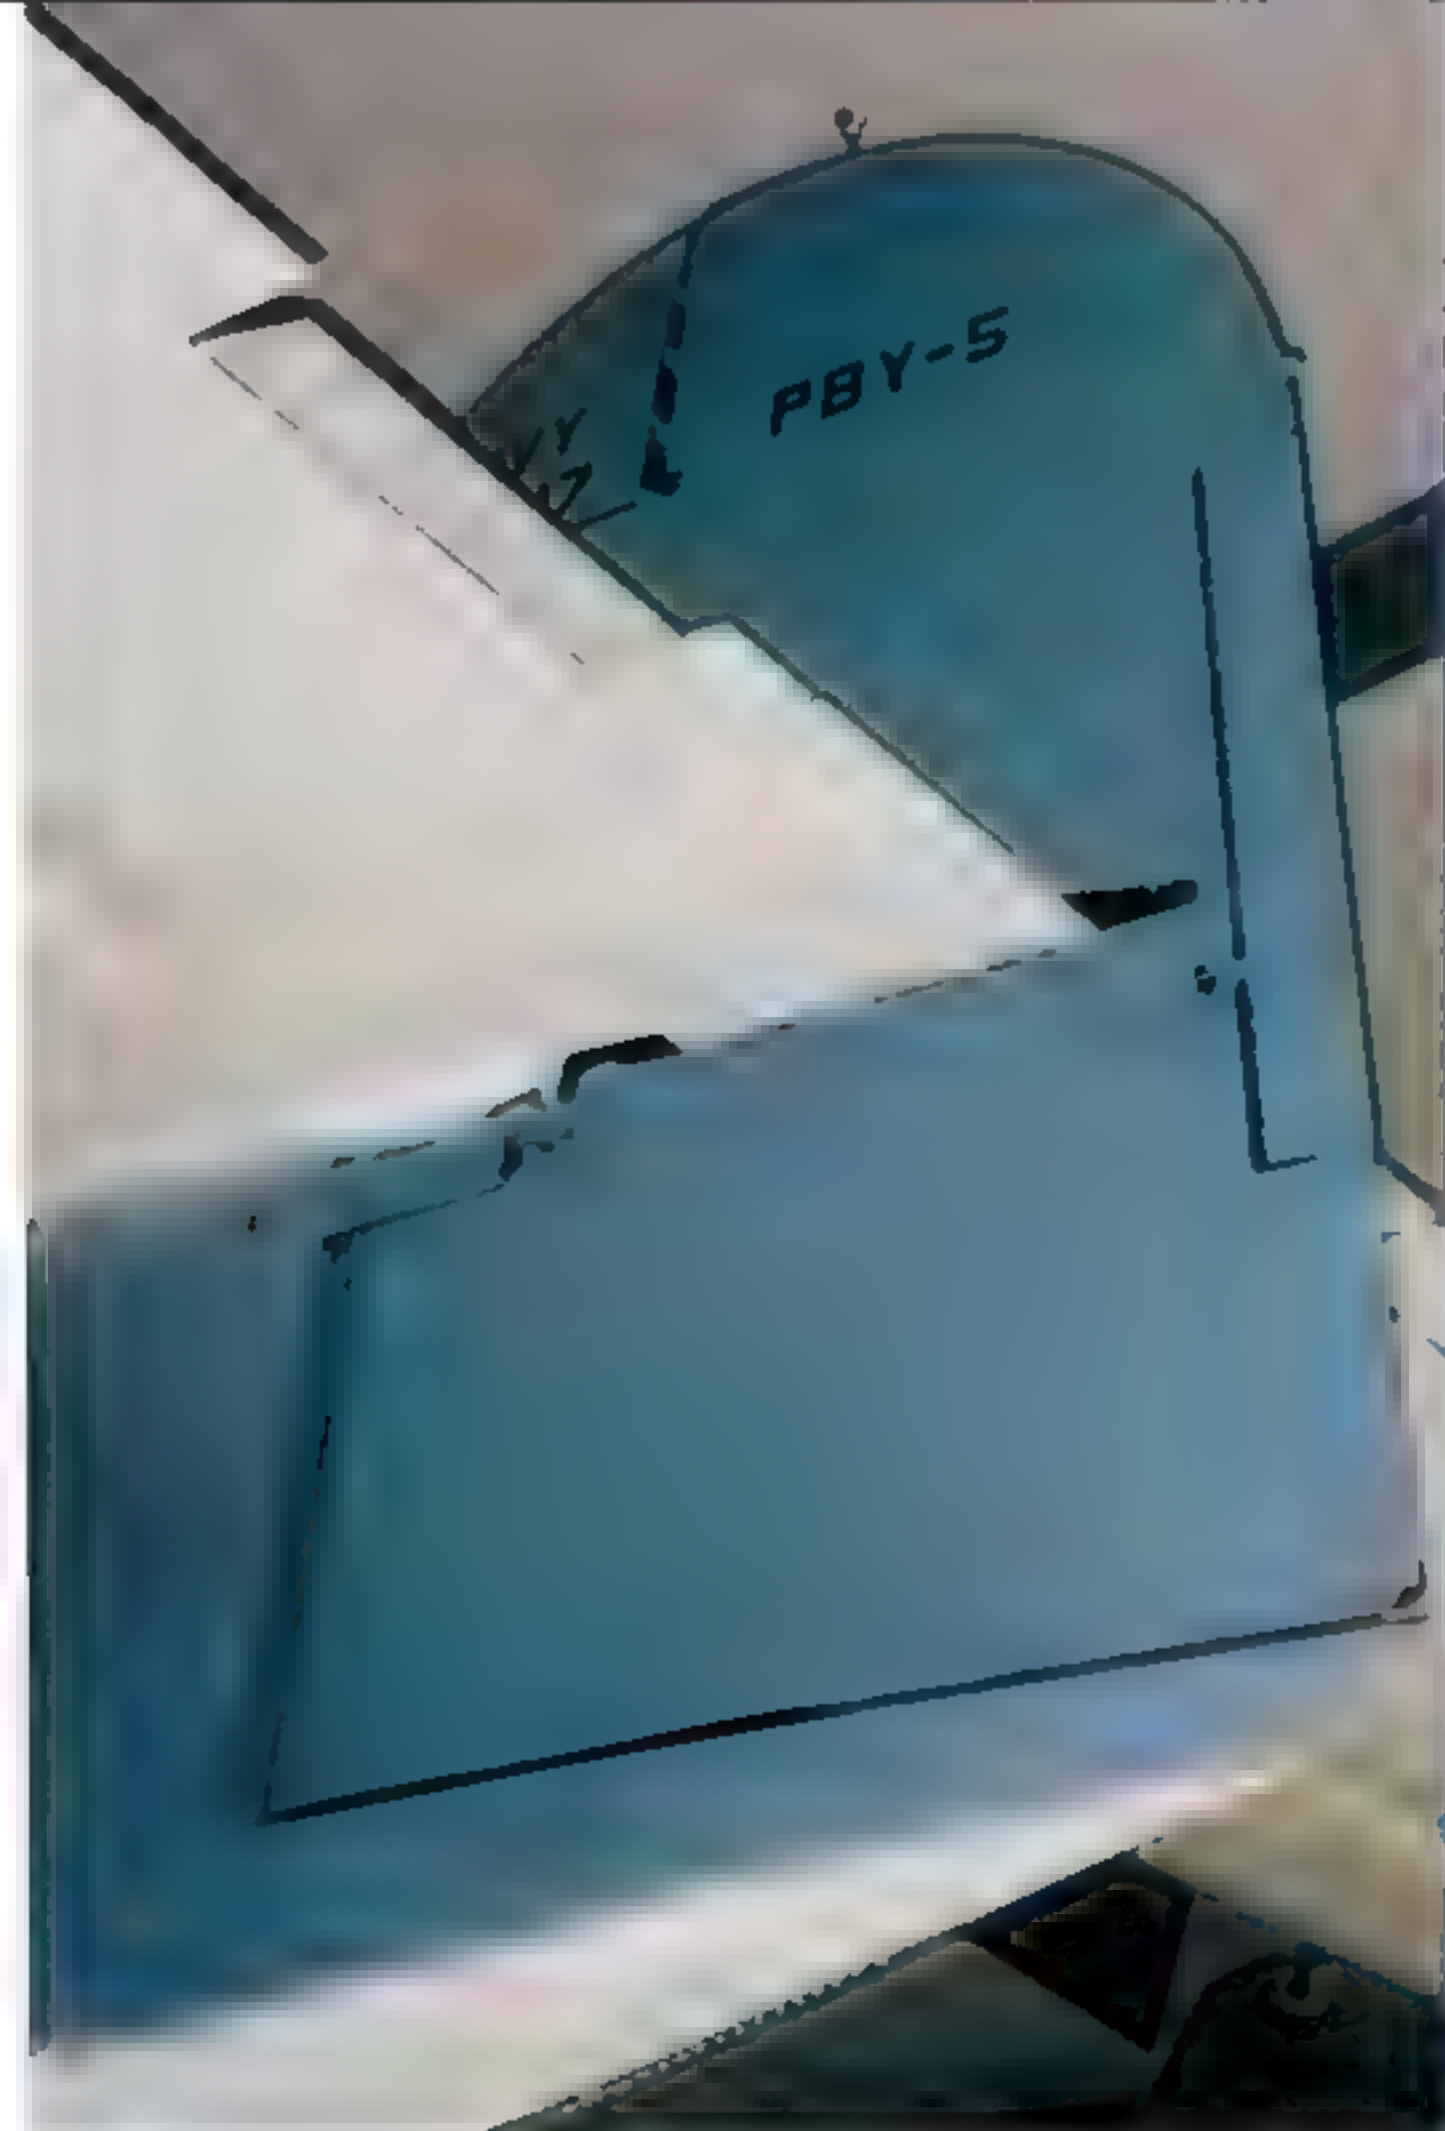
The fin and rudder of the PBY-5 on display at the National Museum of Naval Aviation. The trim tab actuator was only on this side. Both elevators were also equipped with trim tabs. (WES)

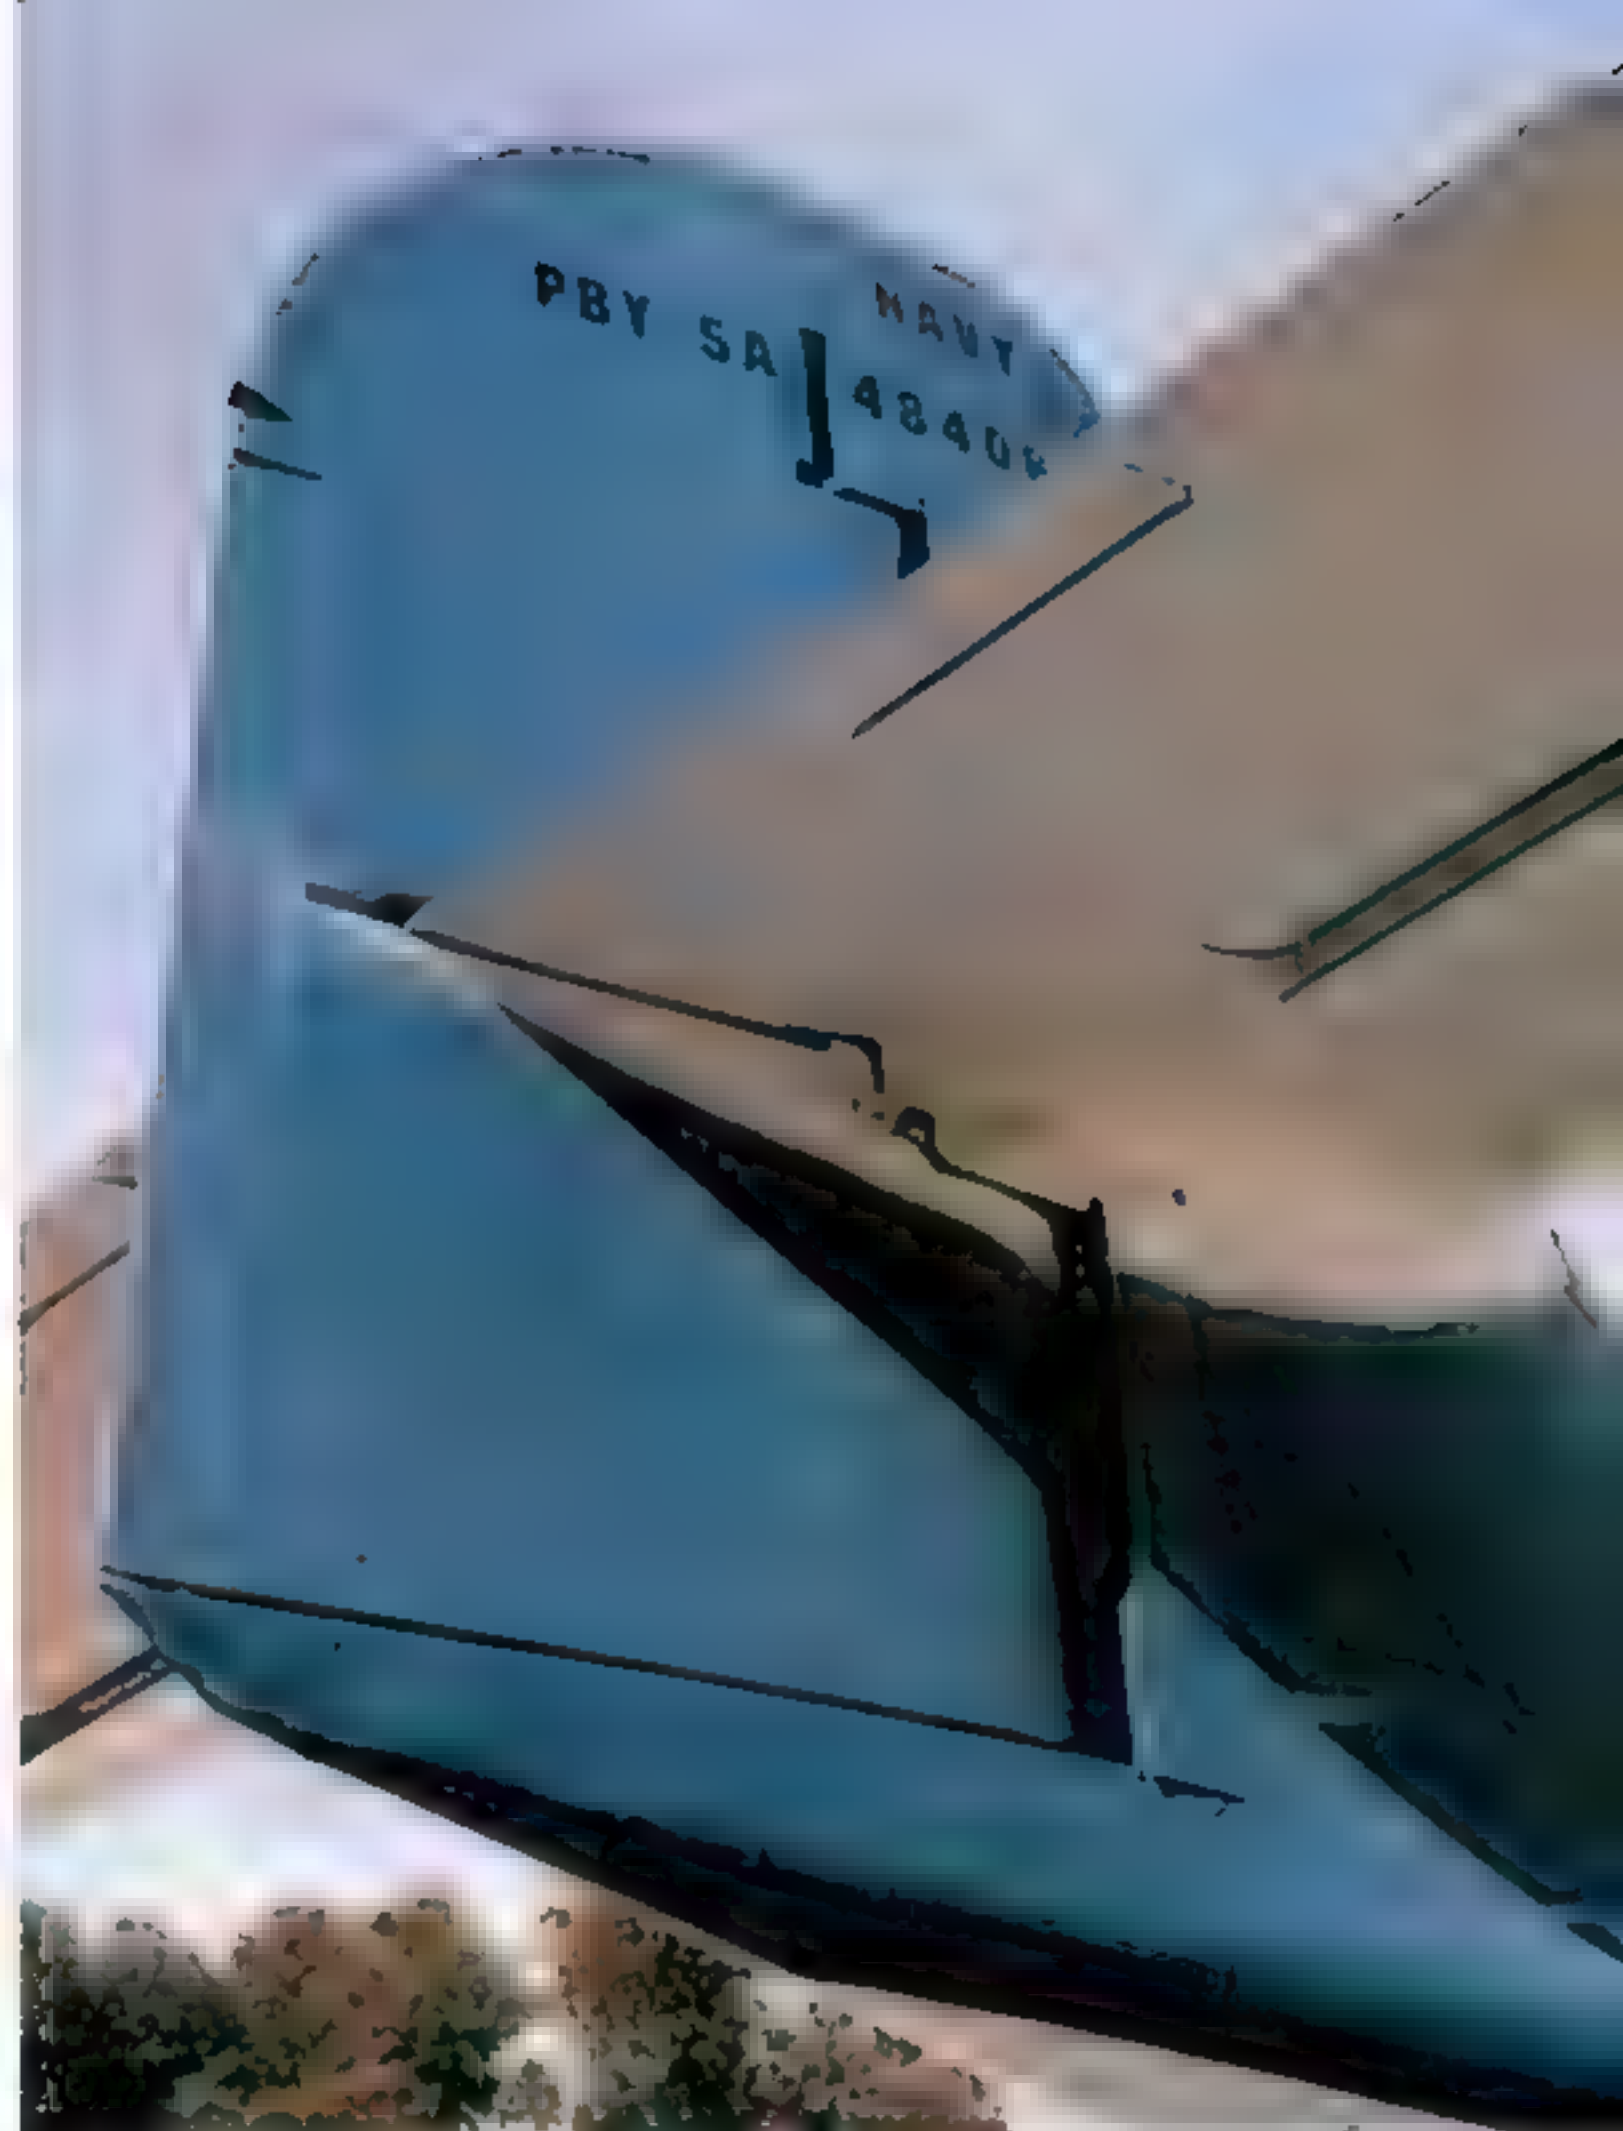
The vertical and horizontal tail, control surfaces and trim tabs of the San Diego Aerospace Museum's PBY-5A. The rudder control cable and control horn are visible just below the horizontal tail. (Richard Dann)
